GREENBRIER AREA PEDESTRIAN SAFETY STUDY

T04-05

MAY 2004

HAMPTON ROADS PLANNING DISTRICT COMMISSION

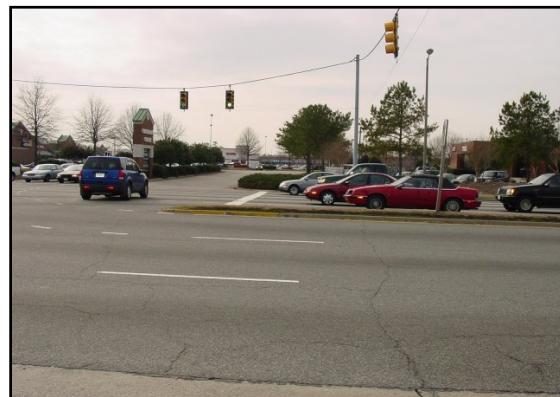
Looking across Greenbrier Pkwy from Greenbrier Mall Entrance at Crossways Boulevard, where no crosswalks currently exist.

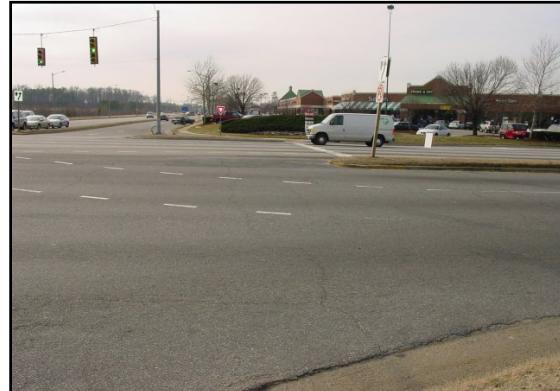
Looking across Greenbrier Pkwy from east side of Eden Way, where no crosswalks currently exist.

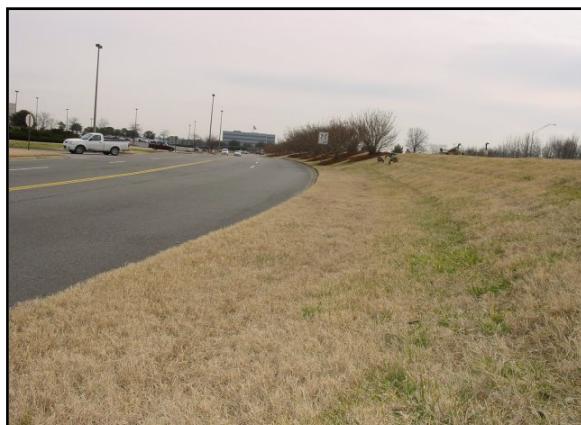
There is currently available space for sidewalks along Mall Ring Road.

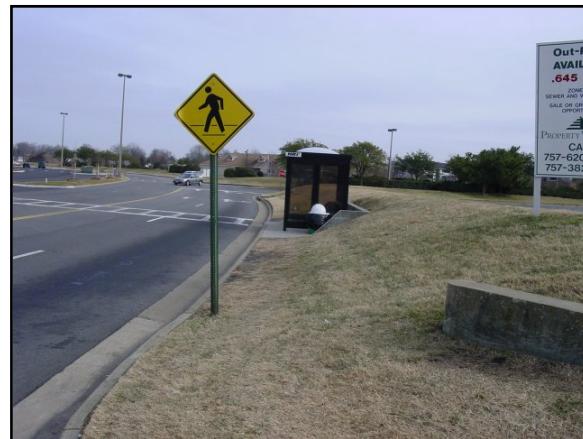
Sidewalks are needed surrounding HRT bus stops.

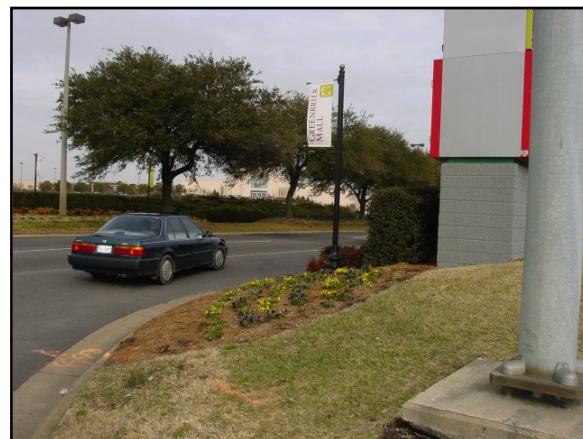
Greenbrier Mall Main Entrance (looking east). No sidewalks currently exist and shrubbery extends to curb.

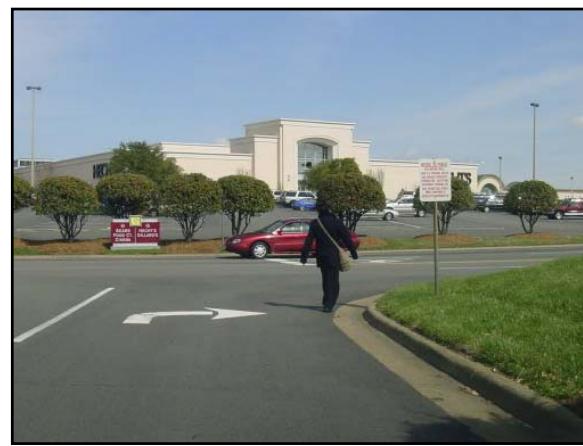
Pedestrians currently walk along the edge of the roadway at some Mall entrances, which is extremely unsafe.

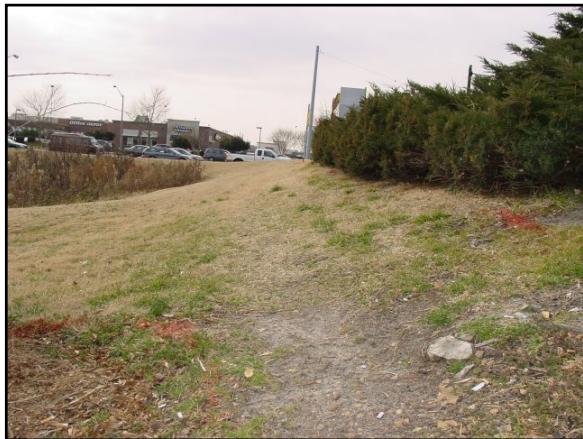
Greenbrier Mall Main Entrance (looking west at the same location as the photo above). A path behind the shrubbery has been worn down by pedestrian traffic.

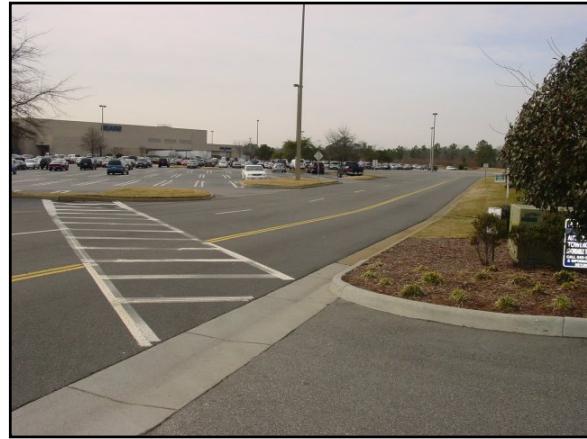
Mall Ring Road location connecting senior residential area to the northeast parking lot at the mall. Needs curb ramp for persons in wheelchairs and sidewalks leading up to the existing crosswalk.

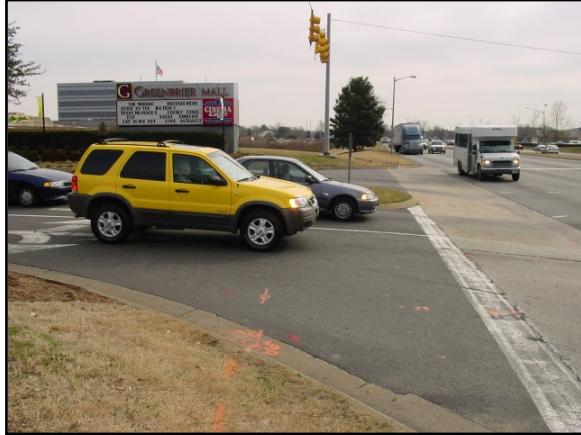
Greenbrier Mall driveway entrances do not have crosswalks or median refuges for pedestrians to safely cross.

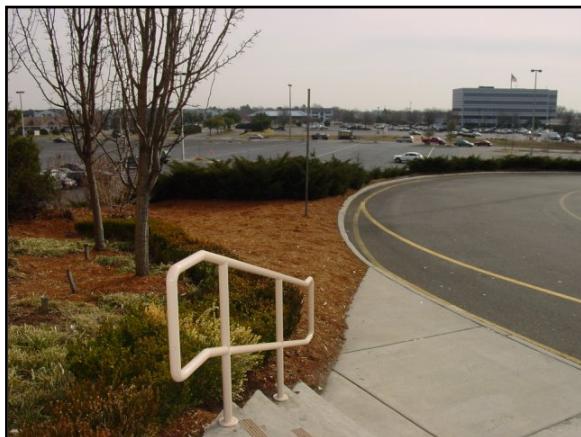
Sidewalks do not provide seamless connections around the mall or to driveway mall entrances.

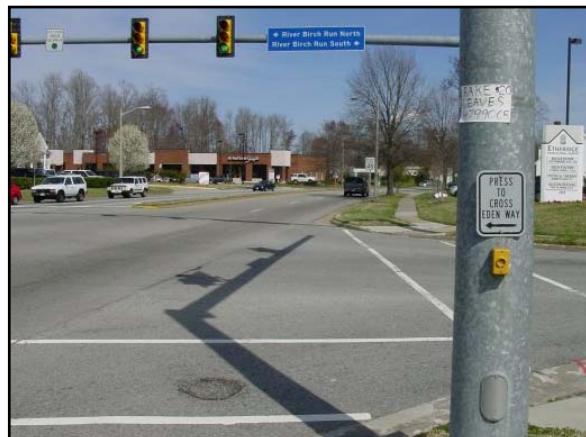
Pedestrian push buttons and crosswalks currently exist for two approaches of the intersection of Eden Way and River Birch Run; however, no pedestrian signals are present to alert pedestrians when it's safe to cross.

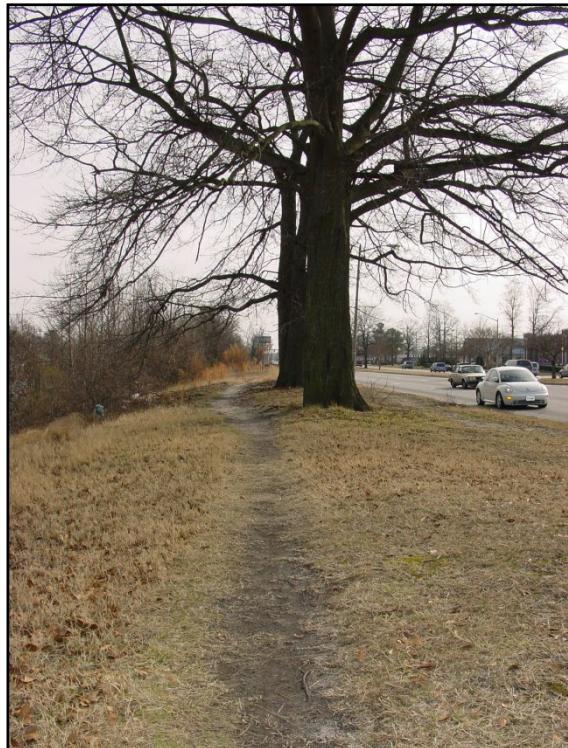
A worn path along Greenbrier Parkway demonstrates pedestrian activity.

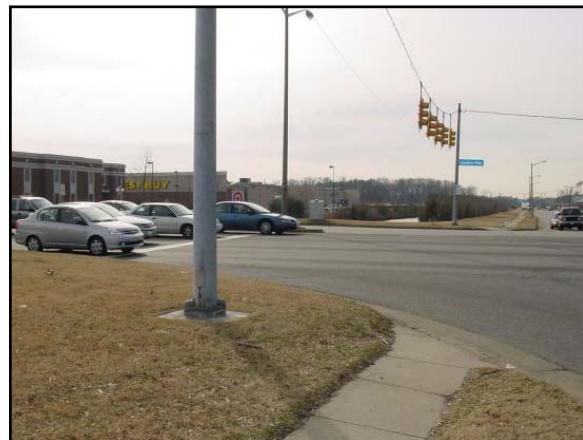
Looking west across Greenbrier Parkway at Eden Way. Sidewalks lead to the intersection on both sides of Eden Way, but no crosswalk or pedestrian signal is provided.

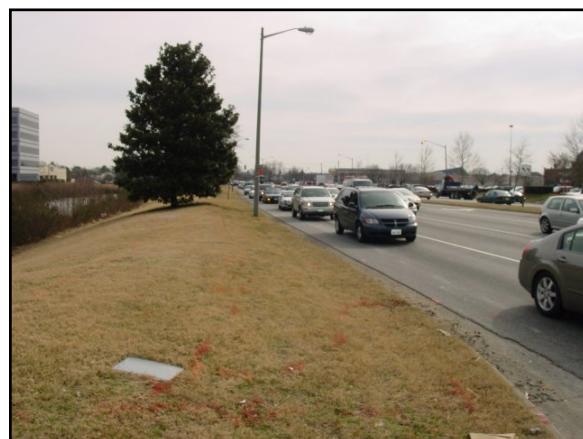
No sidewalks currently exist for a majority of Greenbrier Parkway in the study area.

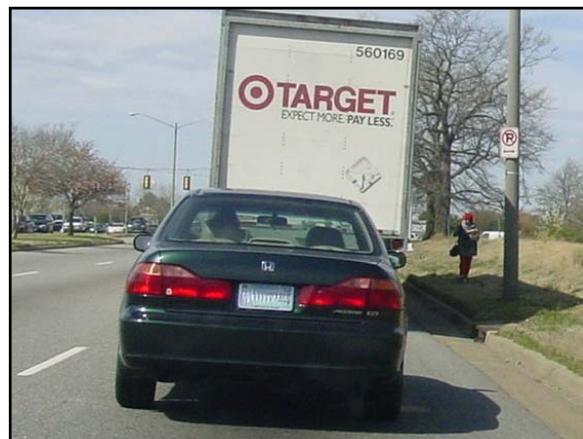
An observed pedestrian walking along Greenbrier Parkway between Eden Way and Volvo Parkway, where no sidewalks currently exist.

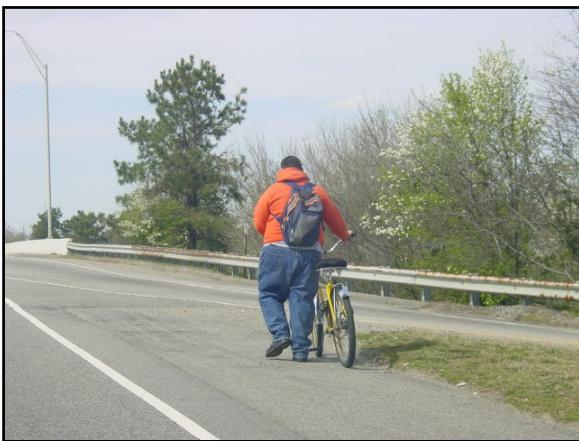
Pedestrians and bicyclists travel along Greenbrier Parkway over Interstate 64 despite the absence of sidewalks and crosswalks, which raises safety concerns.

- Construct sidewalks along both sides of Greenbrier Parkway (as well as crosswalks at Interstate 64 entry and exit ramps) from Jarman Road and across Interstate 64 to connect pedestrian facilities north of the interstate highway. Field observations indicate that local citizens currently walk along this section of Greenbrier Parkway and do not always walk in the safest location. Sidewalks and crosswalks will provide pedestrians the safest locations to travel this section of roadway. This improvement is only recommended if pedestrian facilities are improved north of Interstate 64 so that a safe connection can be made. At a minimum, pedestrian facilities should be provided on one side, preferably the east.

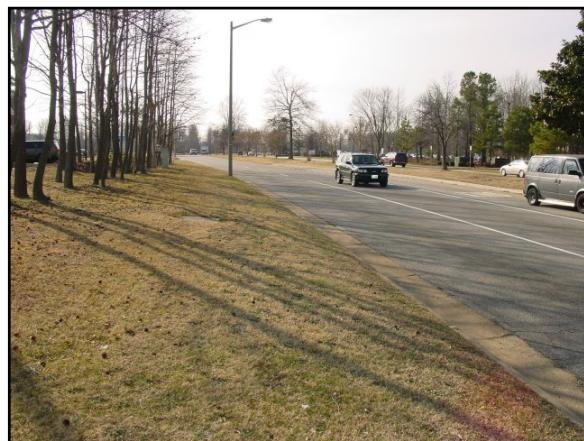
There are no sidewalks along Volvo Parkway from Greenbrier Parkway to Crossways Boulevard.

- Construct sidewalks on both sides of Volvo Parkway from Greenbrier Parkway to Crossways Boulevard (Outside of the study area, it is also recommended to construct sidewalks beyond Crossways Boulevard to connect with existing sidewalks starting at Sams Drive on the north side of Volvo Parkway and to the train tracks, about 600 feet west of Crossways Boulevard, on the south side of Volvo Parkway. This will connect pedestrian facilities in the Greenbrier area with those that are already present in the Battlefield Boulevard area).
- Construct a sidewalk along the north side of Volvo Parkway from Greenbrier Parkway to the mixed use restaurant/business development (about 900 feet east of Greenbrier Parkway).

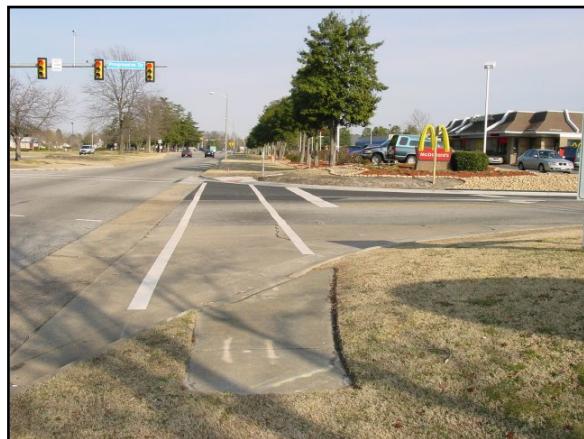
Incomplete sidewalks at the intersection of Volvo Parkway and Progressive Drive

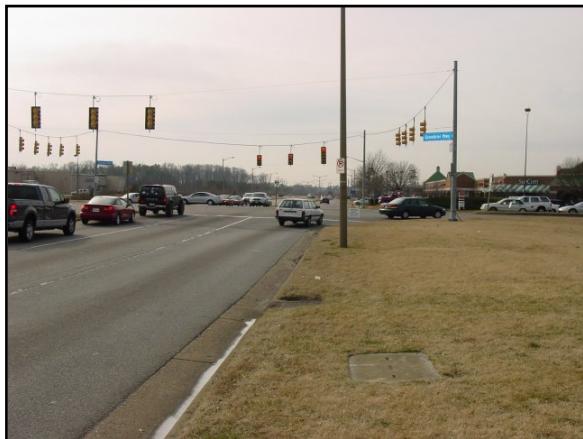
Pedestrians must walk on grass when traveling along some sections of Eden Way.

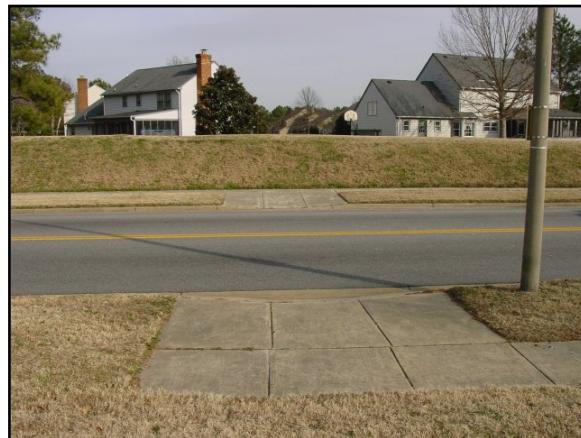
No crosswalk to allow pedestrians to safely change sides to access other portion of sidewalk along Eden Way.

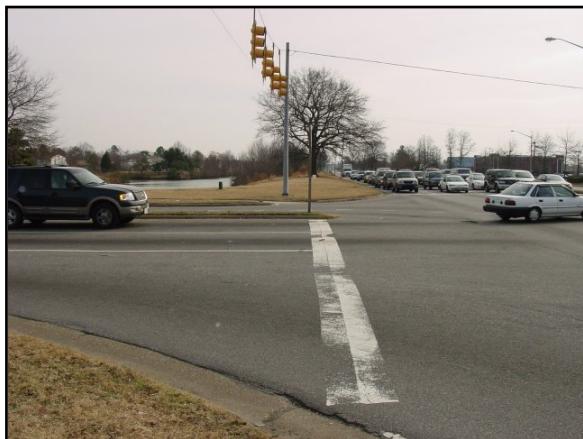
A pedestrian's view while attempting to cross Eden Way at the intersection with Greenbrier Parkway

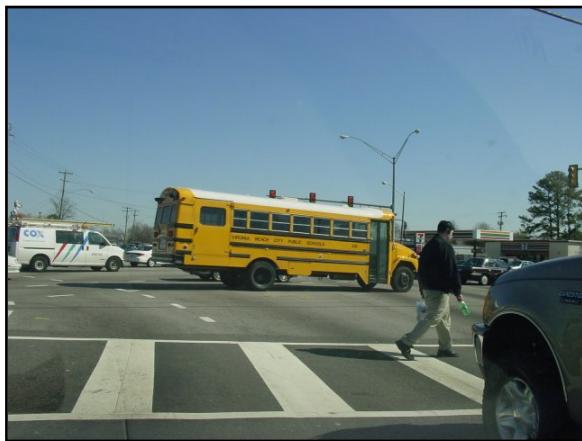
An example of ladder bar crosswalks used in Virginia Beach.

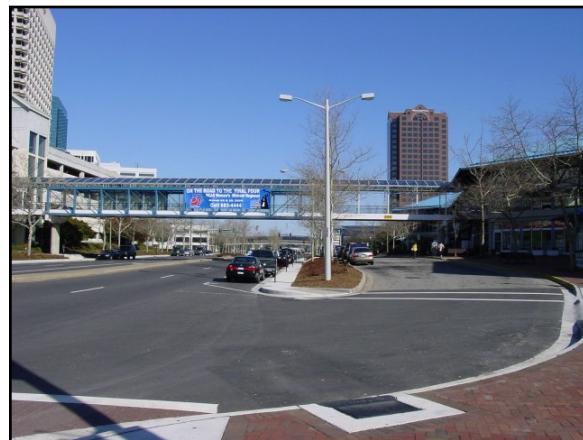
The pedestrian skywalk on Waterside Drive in Downtown Norfolk has been successful because it connects two concentrated activity centers – Waterside Market Place and a multi-level parking garage.

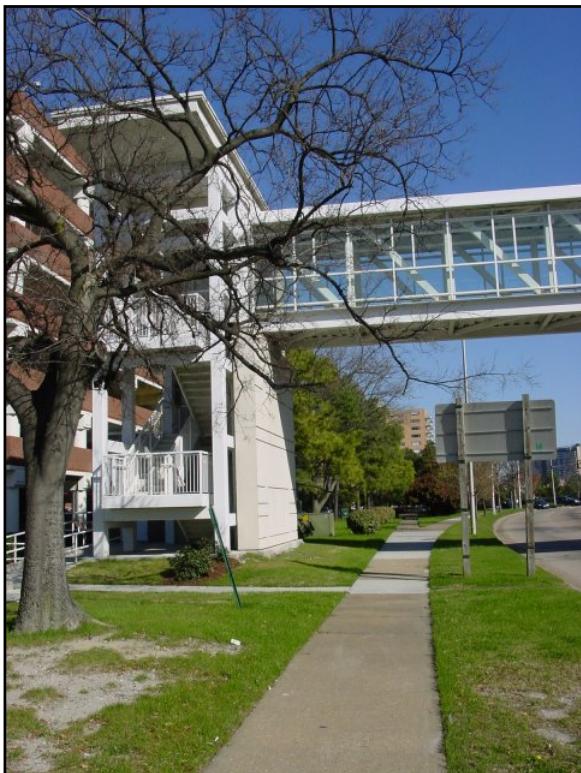
The pedestrian overpass on Brambleton Avenue in Norfolk connects the Hospital with employee parking lots, however, requires pedestrians to use the stairway or elevator.

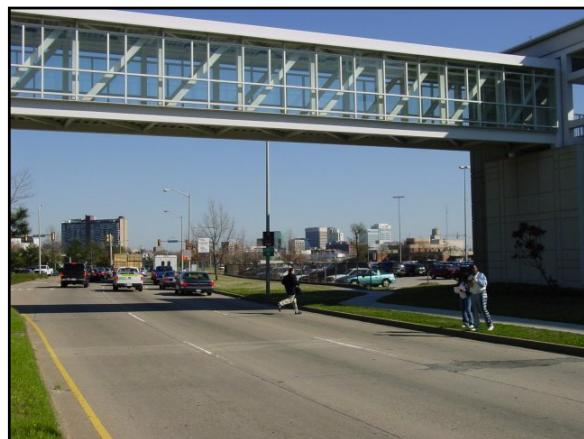
Many pedestrians sprint across Brambleton Avenue rather than climbing the stairs or taking the elevator at the Norfolk hospital pedestrian overpass.

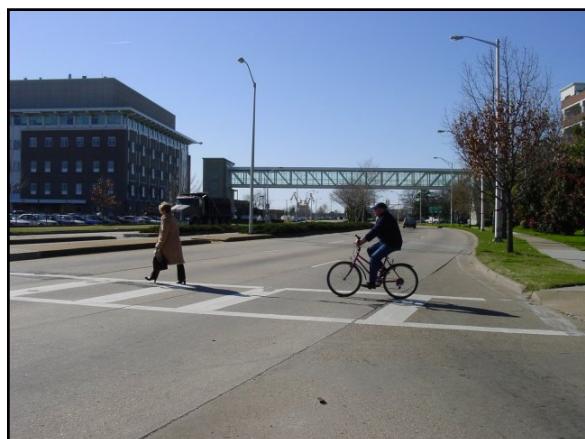
The proposed site for a pedestrian bridge should be at least 600 feet from the nearest alternative "safe" crossing (see third guideline on following page). Here, a crosswalk near the Norfolk hospital pedestrian bridge is about 320 feet away.

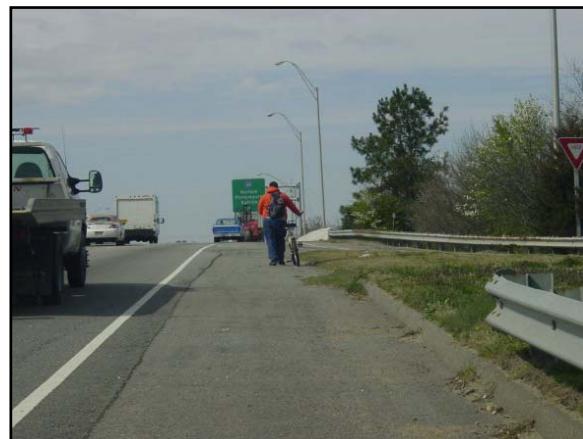
Pedestrians currently walk along Greenbrier Parkway over Interstate 64 where no pedestrian facilities are present.

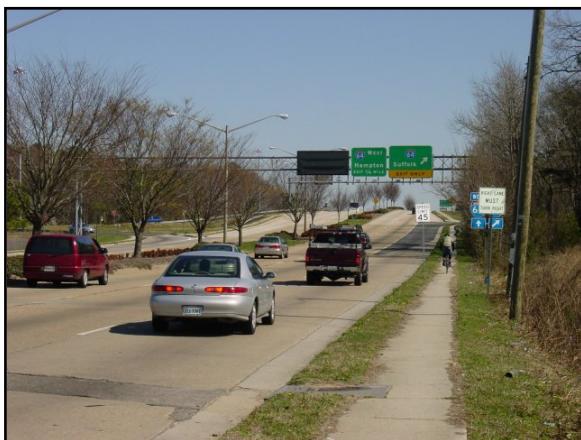
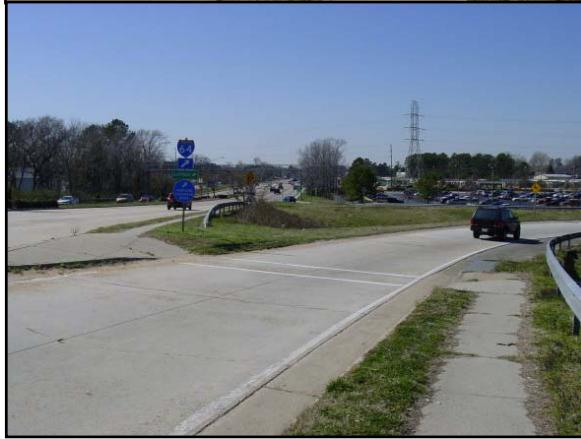
Sidewalks and crosswalks currently exist along both sides of Indian River Road over Interstate 64.

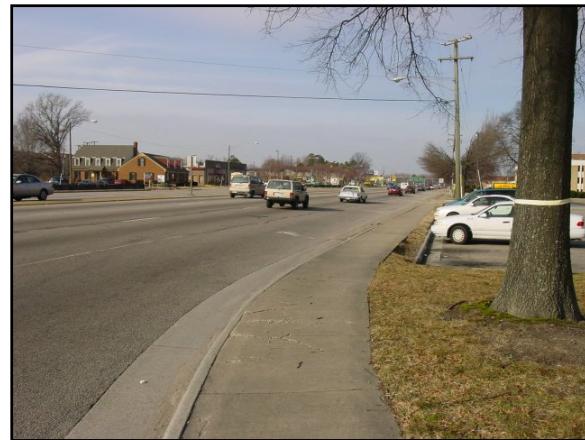
Sidewalks currently exist along Battlefield Boulevard from Wal-Mart Way to the Chesapeake Expressway. Constructing sidewalks along Volvo Parkway will connect the Greenbrier and Battlefield Boulevard areas.

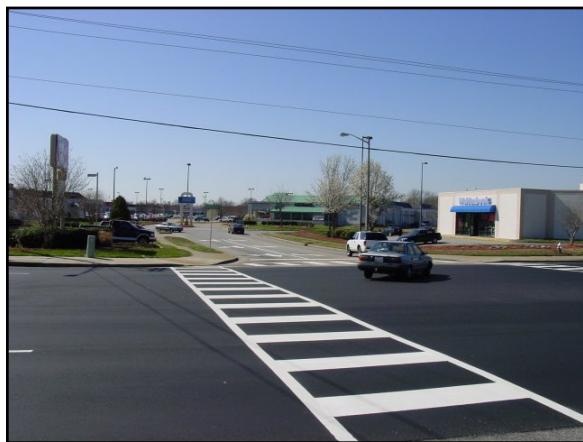
An example of a high-visibility (ladder bar marking) crosswalk used in Virginia Beach.

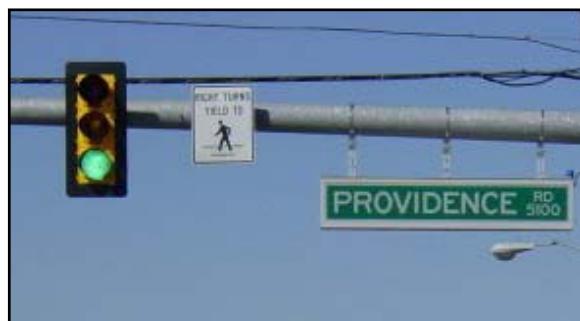
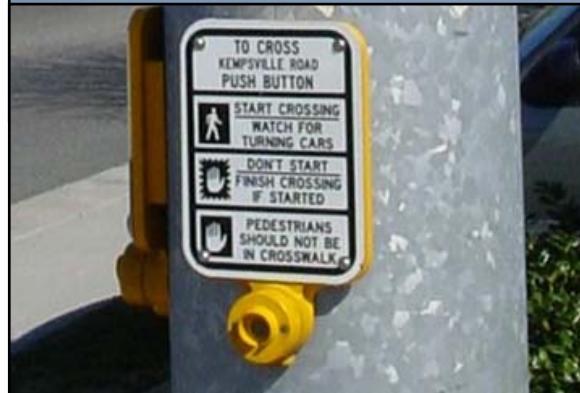
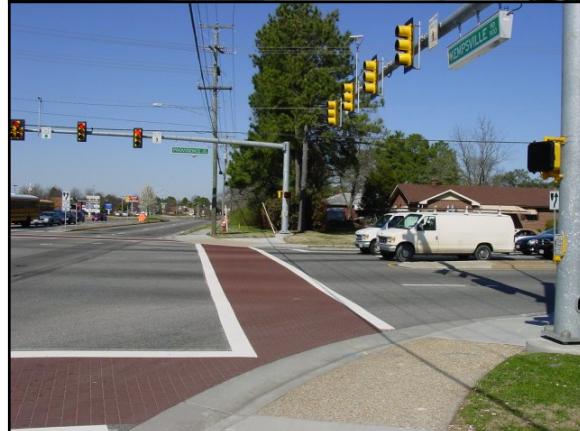
The intersection of Kempsville Road and Providence Road in Virginia Beach contains many characteristics recommended for the Greenbrier Parkway and Crossways Boulevard/Mall Main Entrance intersection, such as stamped asphalt crosswalks, pedestrian signals, and overhead signs.

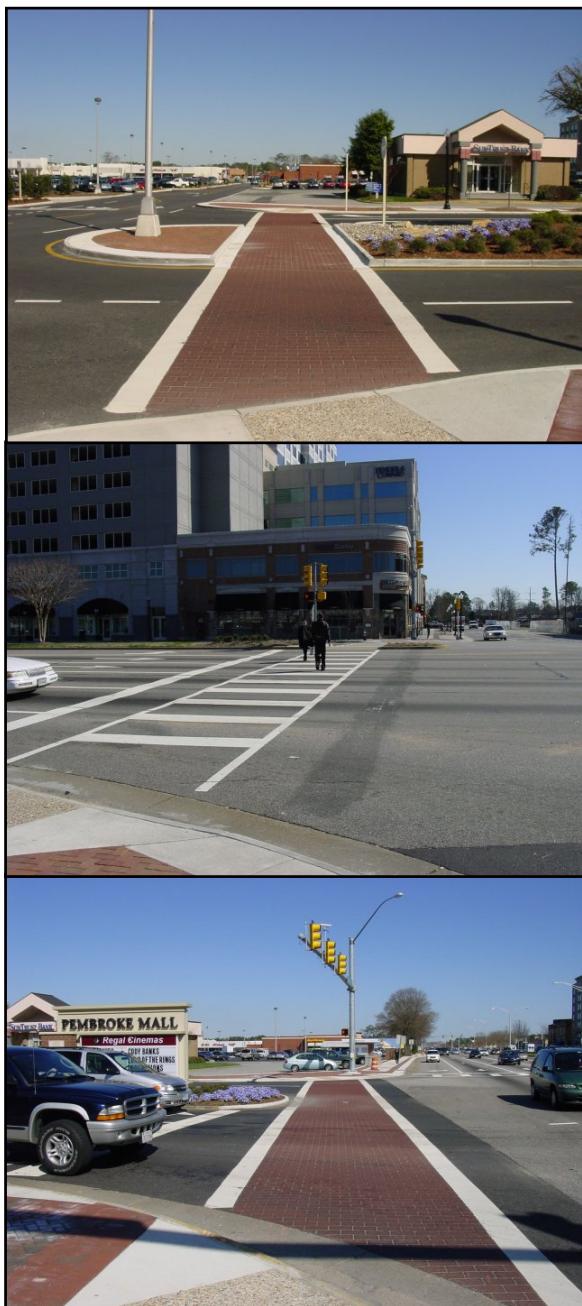
The revitalization effort in the Pembroke Mall area in Virginia Beach incorporates stamped asphalt and ladder bar crosswalks, pedestrian signals, median refuge islands, and streetscape improvements. These features add character to the area and improve pedestrian safety.

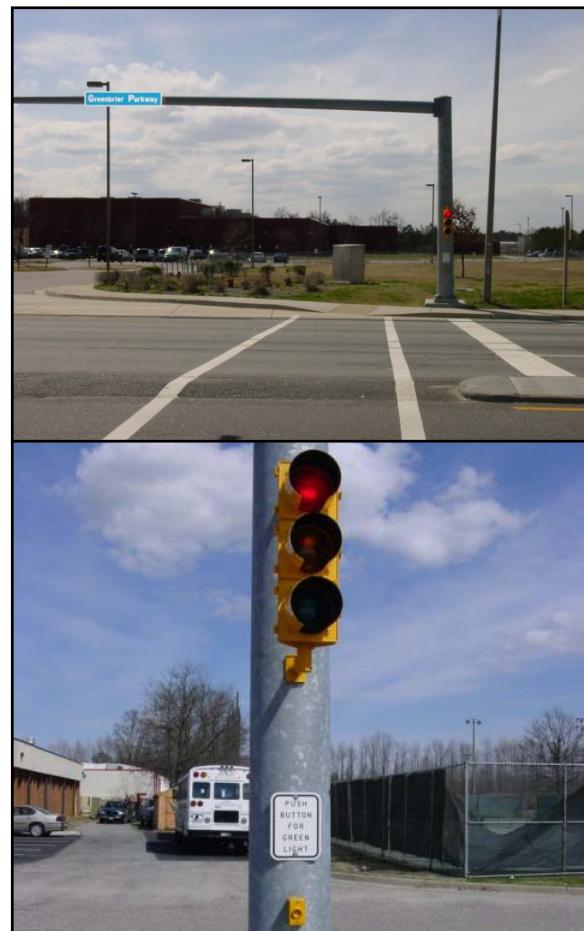
An example of pedestrian signals used in Chesapeake (shown here is the intersection of Greenbrier Parkway and Greenbrier Middle School).

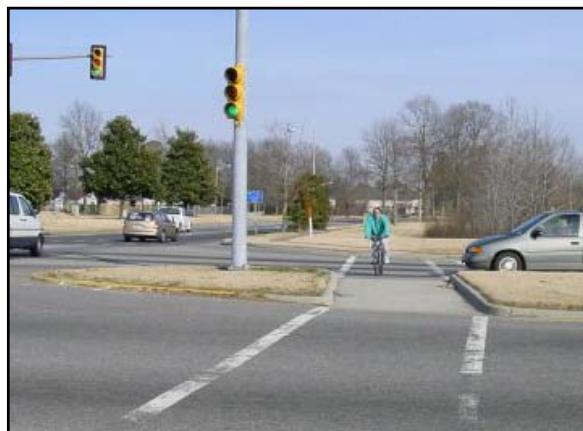
An example of a median refuge island at the intersection of Greenbrier Parkway and Volvo Parkway. Refuge islands allow pedestrians to cross one direction of traffic at a time. They also allow bicyclists to travel safely across the median.

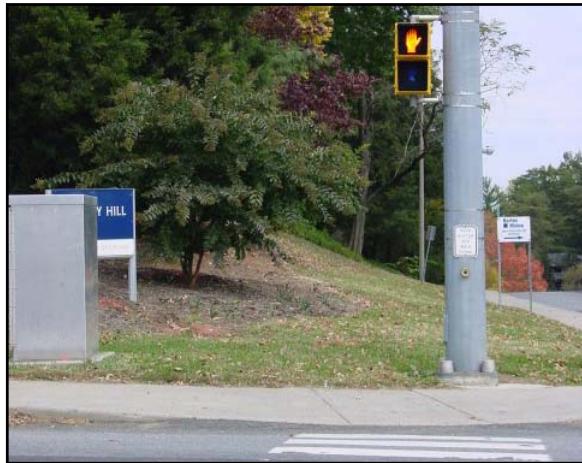
An example of a pedestrian signal used in Charlottesville, Virginia. The hand signifies "stop" and the walking man figure signifies that it is "ok to cross". This type of pedestrian signal is most commonly used.

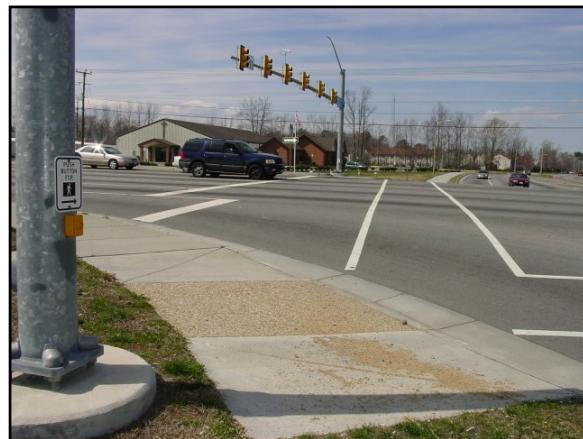
Horizontal bar crosswalks with pedestrian push buttons are currently used at the intersection of Greenbrier Parkway/Butts Station Road and Kempsville Road in Chesapeake. No pedestrian signals are used, however.

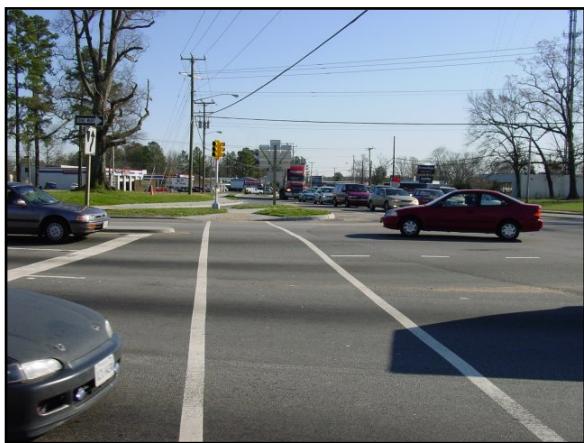
Horizontal bar crosswalks and pedestrian signals with push buttons are currently used at the intersection of Kempsville Road and Battlefield Boulevard in Chesapeake.

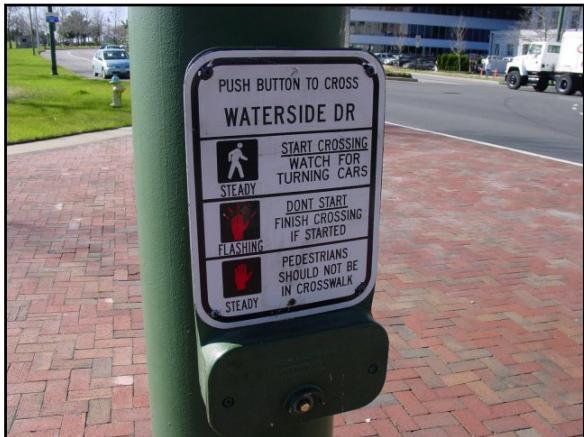
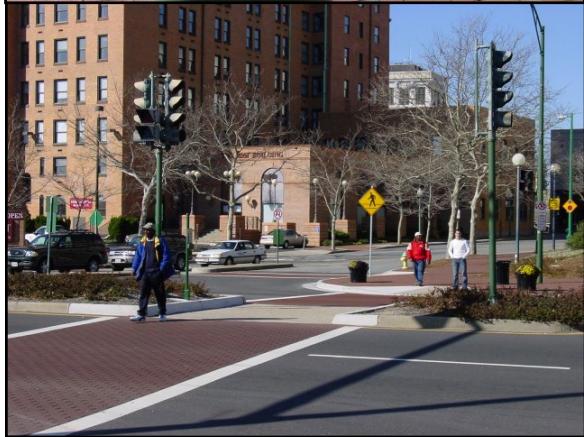
An excellent example of a mid-block crosswalk treatment (located across Waterside Drive in Downtown Norfolk). Features include a high-visibility crosswalk, clear instructions on push button locations, and pedestrian signs and signals.

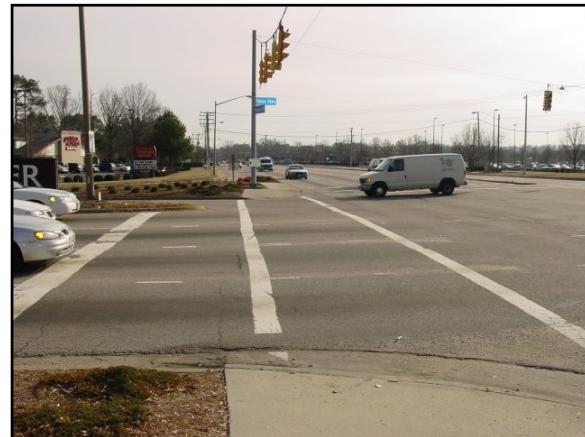
Crosswalks currently exist on all four approaches of the Battlefield Boulevard @ Volvo Parkway Intersection.

- Remove existing horizontal bar markings for the eastbound and northbound approaches and install high-visibility (ladder bar marking) crosswalks on all four approaches. Relocate stop bars as needed.
- Retime signal phasing to provide adequate time for pedestrians to cross the roadway.
- Install pedestrian signals and accessible pedestrian signal push buttons for all approaches.
- Install overhead pedestrian warning signs.
- Provide refuge islands across medians as necessary.
- Provide curb ramps, where they currently do not exist, to align with crosswalks.

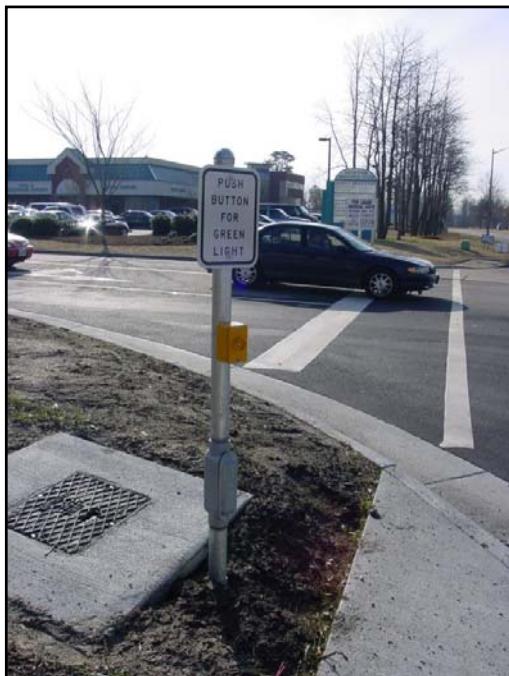
Push buttons for pedestrian crossing currently exist for two approaches of the intersection of Volvo Parkway and Progressive Drive.

- Remove existing horizontal bar markings for the westbound and northbound approaches and install high-visibility (ladder bar marking) crosswalks on all four approaches. Relocate stop bars as needed.

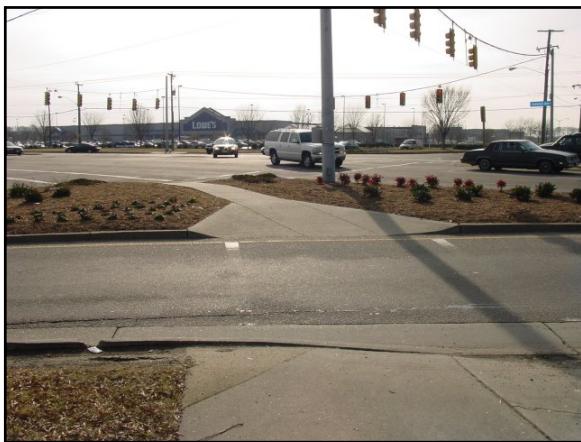
As a result of high traffic volumes at the intersection of Battlefield Boulevard and Volvo Parkway, some crosswalks are no longer visible.

- Continue to maintain/replace worn out crosswalk pavement markings to ensure maximum visibility and safety for pedestrians.
